KEY TO THE FUTURE

Wally Schaefer, Jorvic Vital and Melissa Callejo, Nalco Water, USA, explain the importance of heat exchanger monitoring data in enabling the ammonia plants of the future.

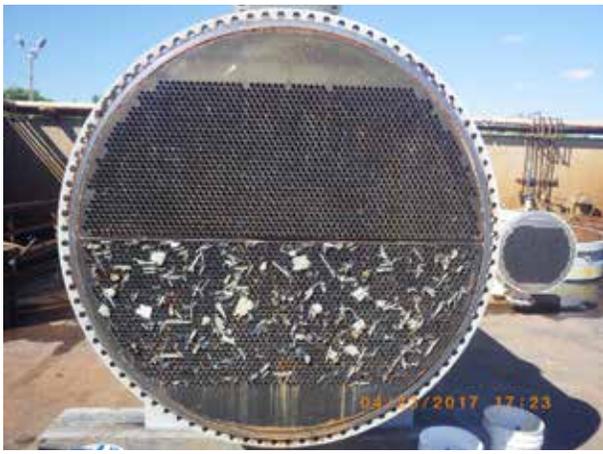
Figure 3. Debris in the inlet of the critical heat exchanger.

OMNI data was used to make a business decision regarding whether to open a critical heat exchanger during a planned maintenance outage or earlier. Historical U-Value trends indicated the heat exchanger was maintaining its operation without any scaling or biofouling issues. However, the cooling water flowrate showed a constant, slow decline (see Figure 2). Based on these metrics, and after confirming that the cooling water network operation did not change, it was highly likely that the water inlet tube sheet was being plugged by debris and restricting the flow of water.

Having the ability to translate these variations to critical information, such as velocity of the water on the tubes, led to the conclusion to open and clean this exchanger during the turnaround and not three months earlier where the market conditions were more favourable for the customer. The plugged tubes were confirmed during turnaround as shown in Figure 3.

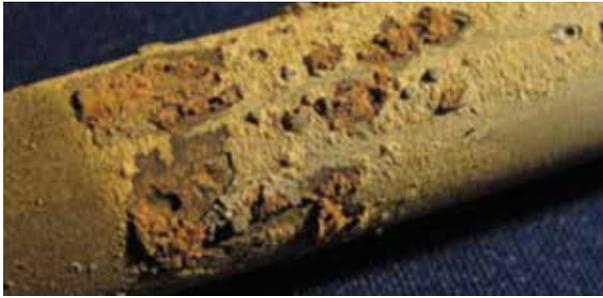
Figure 4. Photomicroscopy and deposit analysis results drive the decision to change cooling water treatment programme.

In this case, a rapid build-up of scale and corrosion was observed on the test exchanger tubes during a 46-day exposure period. Standard corrosion coupon results on the cooling water supply and exchanger outlet were 1.32 mpy and 1.9 mpy, respectively. The corrosion rates for the test exchanger tubes were 1.93 mpy for Exchanger 1 and 3.88 mpy for Exchanger 2. The data points were not unusual since corrosion rates are more aggressive under heat exchanger conditions. Corrosion rates typically double with every 18°F increase in metal temperature. However, further examination of the exchanger tubes revealed localised corrosion with pit depths greater than

20 mils. Photomicroscope (Figure 4) and deposit analysis showed a build-up of mineral scale, primarily composed of iron phosphate, which resulted in under deposit corrosion.

Based on this new understanding of the nature of the scale and performance under actual heat flux conditions, the cooling water treatment program was adjusted, which included an overlay of pyrophosphate to sequester iron and minimise deposition. After these program changes, only slight corrosion was observed, and pit depths were 0.1 mpy, a 99% improvement and a quantum change in asset protection. Ensuring the designed asset life of a tube bundle can save an average of US\$50 000 – US\$75 000 per year for each exchanger (based on bundle replacement cost of US\$450 000 and 20-year lifecycle).
